Review

Physical and Mechanical Methods for the Removal of Lithobionts—A Review

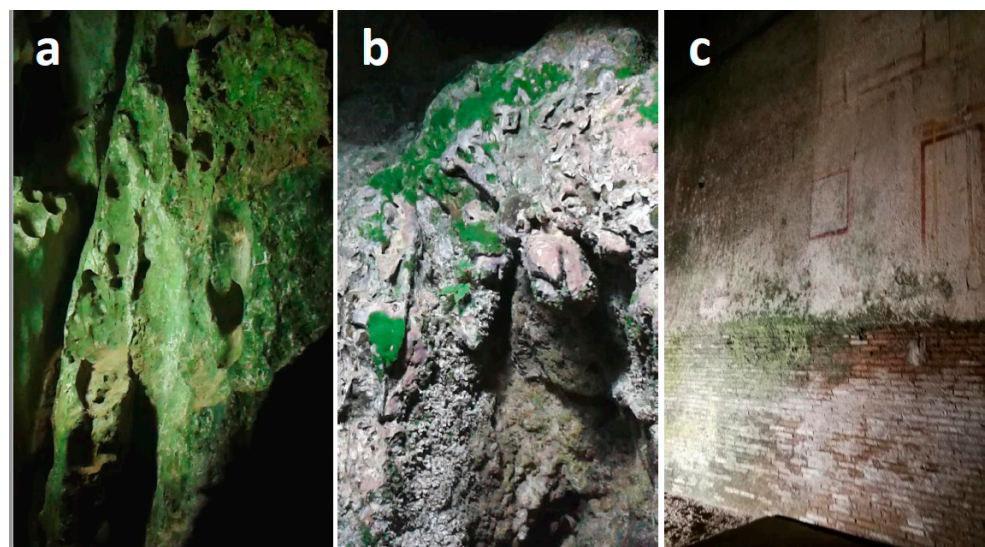
Figure 2. Different patterns of the widespread colonization of phototrophic microorganisms on surfaces of Cueva del Indio (Cuba) (a,b), and Domus Aurea (Rome, Italy) (c).

UV radiation has been used to remove algae, cyanobacteria, and fungi especially in caves, crypts, tombs, and churches, all places where the control of microbial growth is very challenging [8] (Figure 2); recently, it has also been applied outdoors (Table 1). The method is easy to carry out and relatively inexpensive but has some drawbacks, as it poorly penetrates inside substrates and in very thick biofilms [9]. Moreover, it can induce photooxidation in organic materials and interacts with some pigments, effects that limit its use on wall paintings.

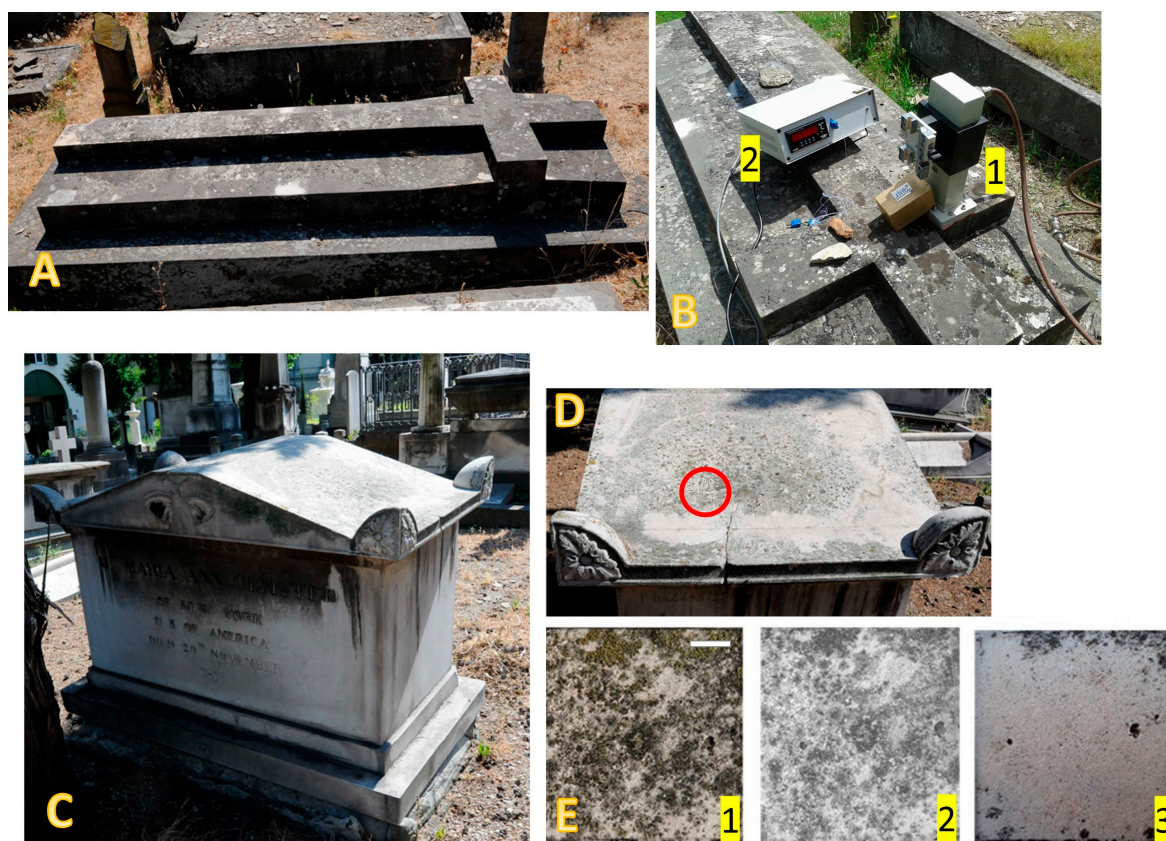
Figure 3. Microwave treatment on two tombstones at the monumental English Cemetery (Firenze, Italy). (A) Crustose lichens and biofilms covered the marble tombstone compromising its legibility and obscuring the stone color. (B) Treatment of the lithobionts of the same tombstone with the microwave applicator (1) of the portable equipment that is connected to a device (2) for monitoring the surface temperature. (C) A marble tombstone partially covered by crustose lichens and biofilms. (D) Surface area (red circle) where the MW treatment was applied. (E) Macro photographs of the treated area before the treatment (1), immediately (2), and about five years (3) after the treatment. Bar = 1 cm.

These in situ studies used a portable MW heating device operating at 2.45 GHz and at a constant power of 1 kW, equipped with an applicator designed to be contiguous to the surface. The geometry of the applicator allows users to localize the MW field distribution in a semi-ellipsoidal volume of the treated material, with an elliptical surface footprint 4 cm × 3 cm in size and a depth of approx. 1.5 cm [29] (Figure 3). The device can control the emitted power, maintaining the monitored surface temperature approximately constant at the desired value. Furthermore, the heating time was minimized to avoid thermal stresses to the substrates.

A key aspect is that MW radiation heats only targets containing water, thus selectively treating living cells that contain a higher water content than that of the materials hosting them. When exposed to the oscillating microwave field, the water molecules of both lithobionts and the stone move (ionic conduction) and rotate (dipolar rotation), with their friction resulting in heat generation and increase in temperature. After removing the microwave applicator, the molecules stop moving and vibrating, and the temperature comes back rapidly by emitting blackbody radiation in the IR range (9–12 μm) or dissipating the heat by conduction [34]. Accordingly, microwave irradiation does not impact rock surfaces with temperature shifts similar to those used in pulsed laser irradiation (see Section 5), which instead may cause thermal stress and the melting of rock-forming minerals [33].

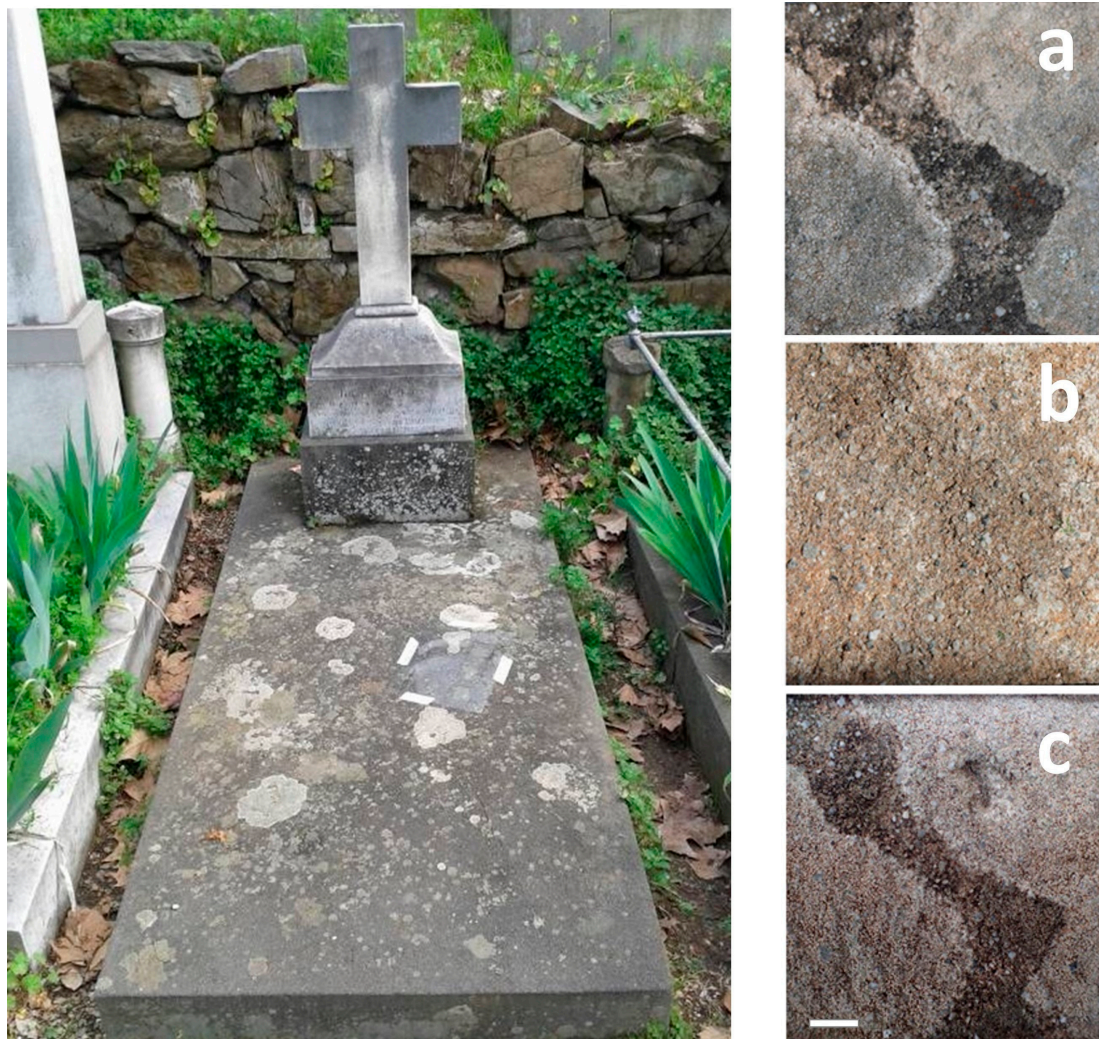
Figure 4. A marble tombstone of the monumental English Cemetery in Florence (Italy). Close-up of an area with the lichen *Circinaria caesiocinerea* (a). The same area, three months after the lichen's removal by using a soft scraper and deionized water (b). The same area, four and a half years after the mechanical treatment (c). The picture clearly shows that it was unsuccessful as the lichen regrowth pattern is identical to that before the treatment. Bar = 1 cm.

A variety of mechanical tools and measures for the treatment of biofilms and lichens have been applied such as brushing, scalpels, sand blasting, air abrasive, low-pressure washing, and vacuuming. Despite showing efficiency in some cases (for example, see [61]), these methods have proved poorly effective in the long-term for their superficial action [32] (Table 4). They detach biological layers from the surfaces, but lithobionts are often located inside the material, being able to penetrate pores, fissures, and cracks. Therefore, it is not possible to reach them mechanically and residues in the form of single viable cells or whole colonies are a source for the rapid reoccurring of colonization. Many crustose lichens show a close interaction with the stones, and their mechanical removal is not a good choice because the substrates can be severely damaged, and lichens' fragments can remain on and inside the stone [62]. The mechanical treatment of lichens covering a sandstone tombstone (English Cemetery, Florence, Italy) seemed successful, but it actually did not remove the whole thalli (Figure 4). In fact, recolonization started after one year and, after about five
