# Lichens and Fungi on Sandstone Tombs at the Historical Jewish Cemetery in Wrocław (Poland)

Elżbieta Pląskowska <sup>1</sup>, Katarzyna Patejuk <sup>1</sup>, Marek W. Lorenc <sup>2</sup> and Jakub Grzeszczuk

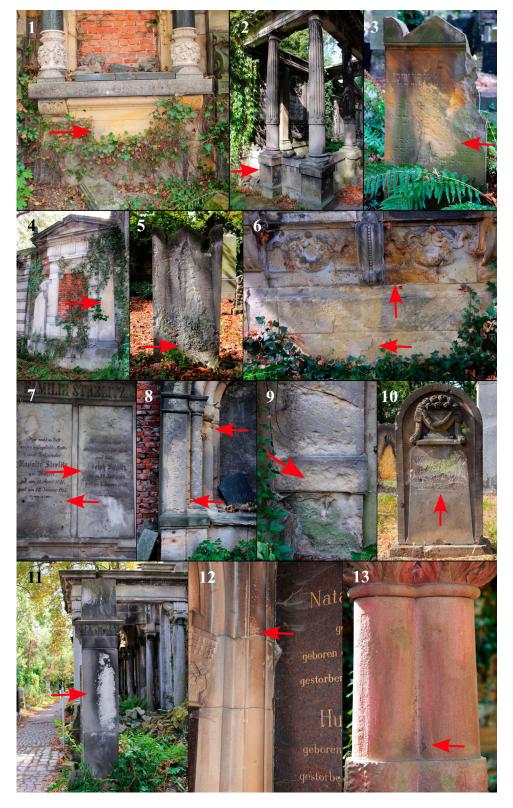
Figure 1. Gravestones at the historical Jewish cemetery in Wrocław (Poland) with traces of biodeterioration. Red arrows mark sampling locations.

The degree of biodeterioration of the examined tombstones varied. Changes in their structure occurred in various parts of the monument: on the pedestal (No. 1, 2, 6, 9, 13), in the middle or bottom part of the mainboard (No. 3, 5, 7, 10, 11), and on the columns (No. 4, 8, 12). The degree of damage to sandstones from Wartowice ranged from 10% to 40%. The most damaged by the microorganisms were monuments No. 5 (40%), 6 and 8 (30%), while the least were No. 4 (10%) and 1 (15%). A monument made of sandstone from Rakowice Male was also damaged at the level of 15%. Tombstones made of stone brought from Żerkowice were destroyed at levels of 5% and 20%. The weakest biotic destruction of the stone was found on tombstones made from sandstones from the Kłodzko region (Radków and Słupiec) - 5% of the surface was noted to be damaged.
